NASA Contractor Report 145326

Flight Service Evaluation of
Kevlar-49 Epoxy Composite
Panels in Wide-Bodied
Commercial Transport
Aircraft - Fourth Annual
Flight Service Report

LOCKHEED-CALIFORNIA COMPANY
BURBANK, CA 91520

April 1978

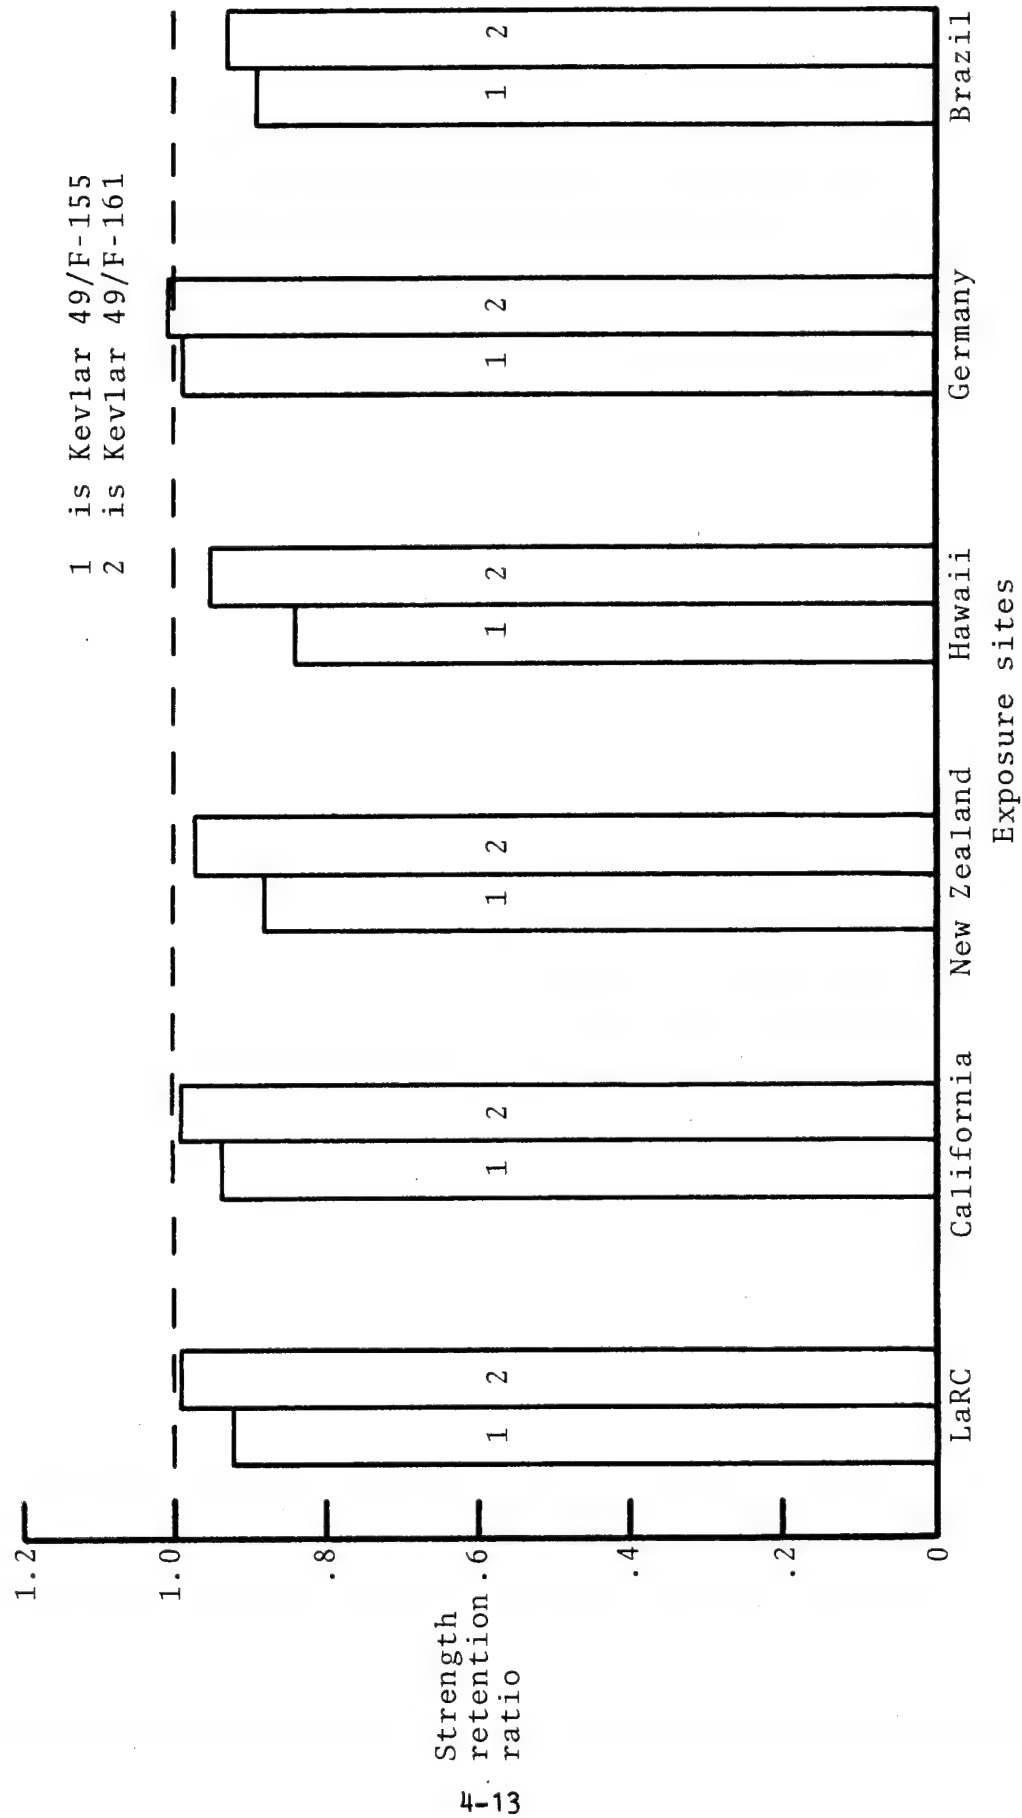
Figure 6. RT Flexure Strength Retention of Kevlar/Epoxy After 3 Years
Outdoor Ground-Based Exposure

strength retention for the Kevlar-49/F-155 Hawaii specimens is shown in Figure 6. Very little strength changes have occurred for the Kevlar-49/F-161 flexure specimens after 3 years exposure at all six locations as shown in Figure 6.

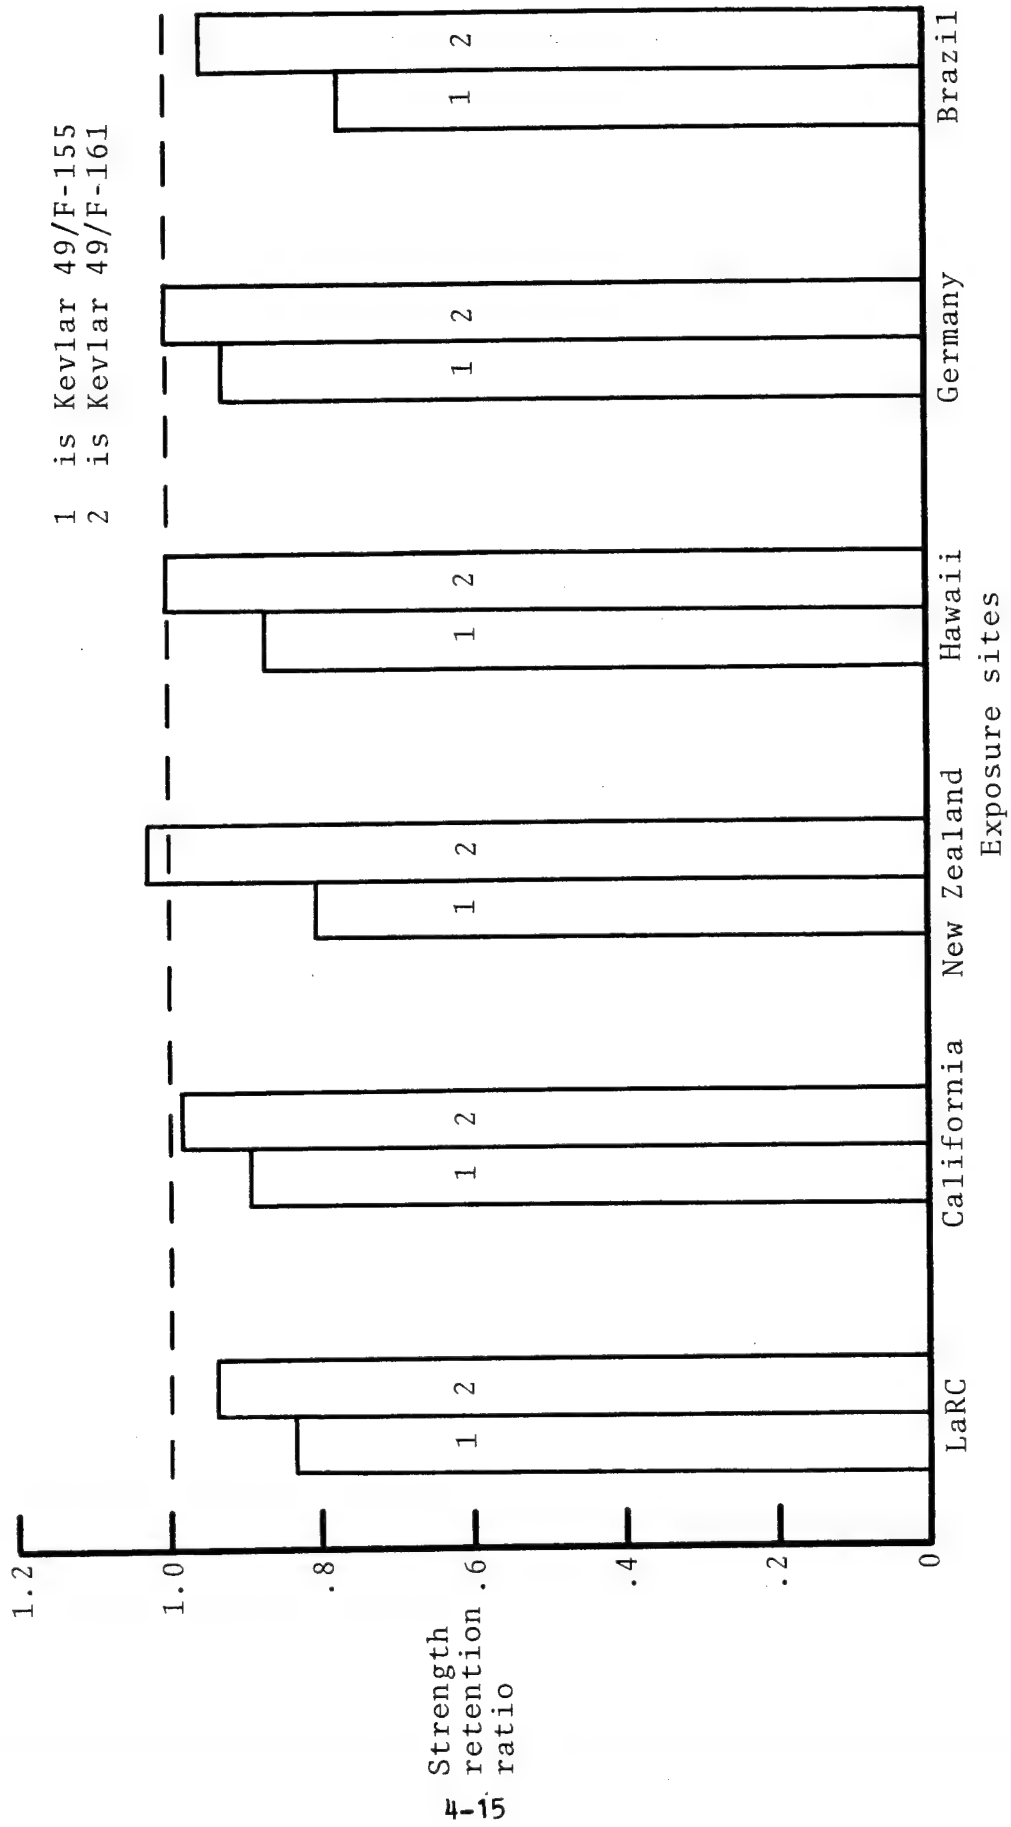
Figure 8. RT Shear Strength Retention of Kevlar/Epoxy After 3 Years
Outdoor Ground-Based Exposure

The largest short beam interlaminar shear strength reduction occurred after 3 years exposure in Brazil. A 76 percent strength retention for the Kevlar-49/F-155 Brazil specimens is shown in Figure 8. The largest strength reduction for the Kevlar-49/F-161 shear specimens occurred after 3 years exposure at the Langley Research Center. This strength reduction was only about 6 percent.

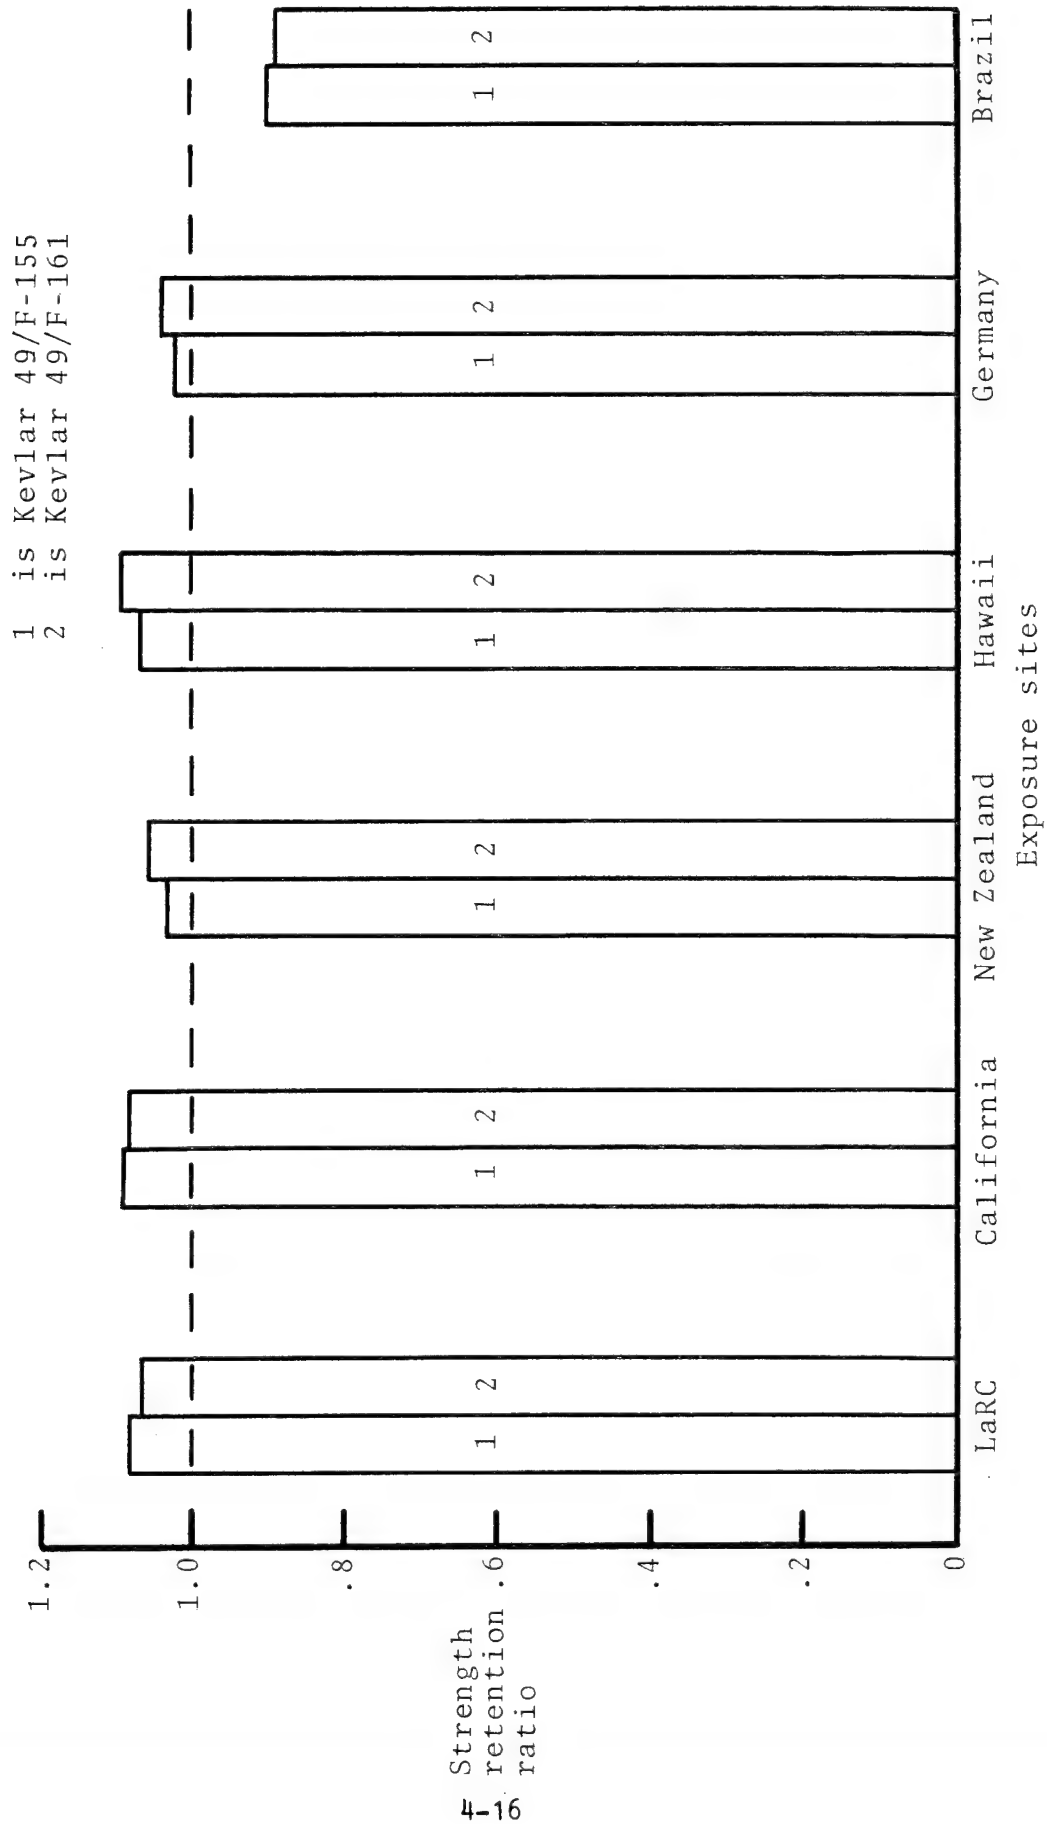
Figure 9. RT Compressive Strength Retention of Kevlar/Epoxy After 1 Year Outdoor Ground-Based Exposure

The 1 year compression strength increased compared to the baseline except for the specimens exposed in Brazil which showed a 10 percent strength reduction as shown in Figure 9. The 3 year compression strength decreased except for the specimens exposed in Brazil which showed a 2 to 4 percent strength increase compared to the baseline specimens as shown in Figure 10. Scatter in the data and a limited number of tests are probably the cause of variations in data trends.

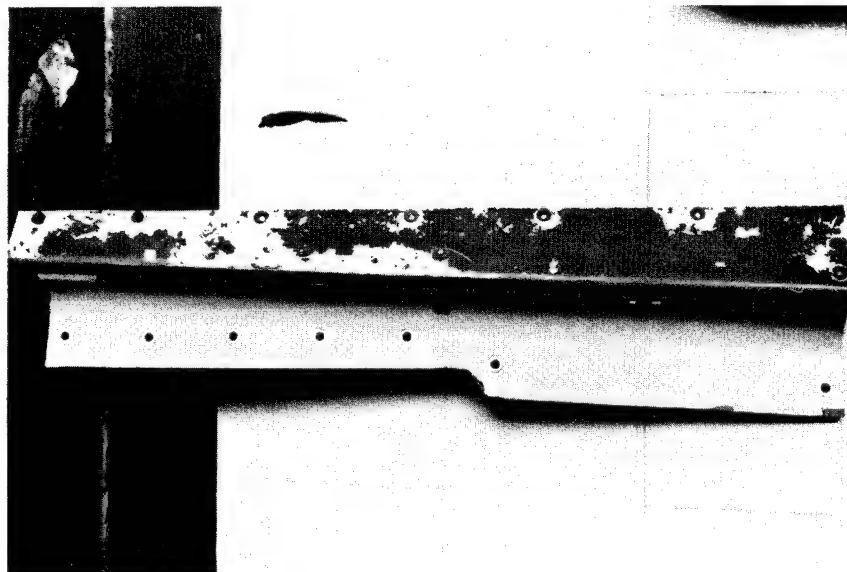
Figure 24. Air Canada LH Underwing Fillet - Exterior Surface

- 2) No surface damage or defects were noted on either surface but considerable paint loss was observed in the upper exterior surface with the Kevlar-49 surface exposed. (Figure 24).
- 3) Slight fraying was observed on all fastener holes. Hole deformation was noted on four holes in the lower area, and seven holes in the upper area. (Figure 25). Four of these were only slight deformation, but the others had maximum dimensions of 0.6 cm (1/4 in.), and 1.1 cm (7/16 in.) in some cases from the original 0.5 cm (3/16 in.) diameter. This represented some increase in the incidence of hole deformation over that observed in 1976, specifically three of the holes in the lower area which were noted to have a slight deformation in 1977, and three of the holes in the upper area observed to have deformation up to 1.1 cm (7/16 in.) in 1977.

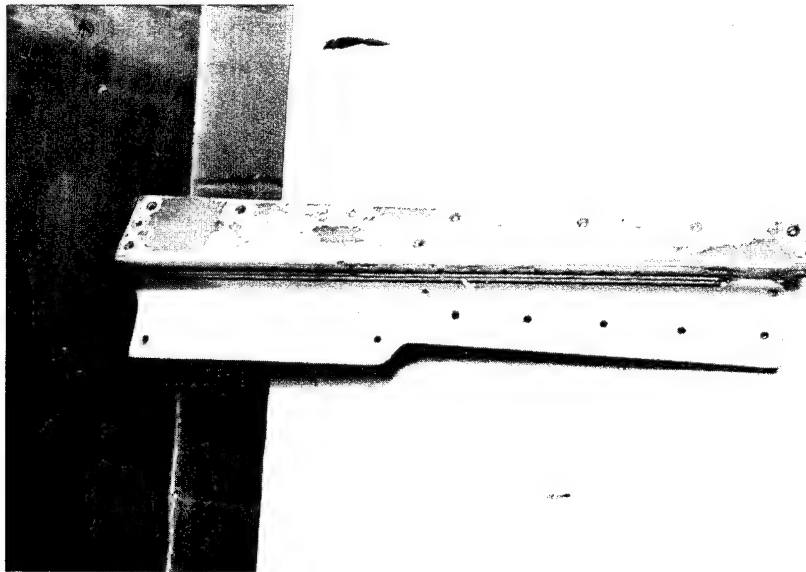
Figure 26. Air Canada RH Underwing Fillet - Exterior Surface

- 1) The panel weight was 0.85 kg (1 7/8 lbs.).
- 2) No damage or defects were noted on either surface, but considerable paint loss was observed on the upper area with the Kevlar-49 surface exposed. (Figure 26).
- 3) Slight fraying was observed around all fastener holes. Hole deformation was noted on eight holes in the upper area, four to a slight degree and the others deformed to a maximum dimension of 1.1 cm (7/16 in.) (Figure 27) from the original 0.5 cm (3/16) diameter. One hole on the lower edge was slightly elongated. This represented an increase in the observed number of elongated holes since their

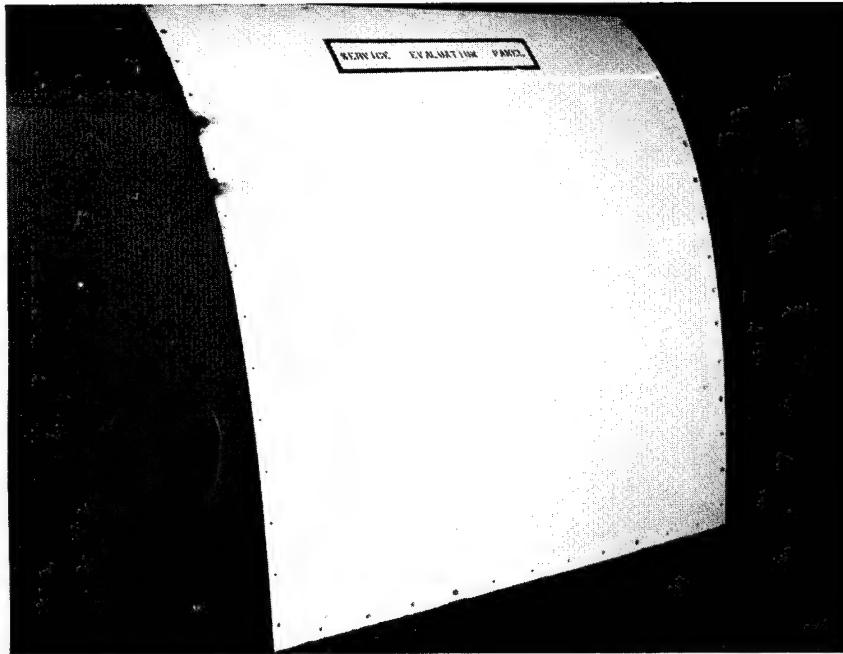
Figure 31. TWA LH Wing-Body Fairing - Exterior Surface

- 1) A small crack 0.3 cm (1/8 in.) in length was observed in the center, aft area. This crack had not been previously observed.
- 2) The outer and inner surfaces showed no other defects or damage, although some paint loss was observed on the forward edge. (Figure 31).
- 3) Slight fraying of fastener holes was visible from the inner surface only. (Figure 32). Six holes were observed to have deformation with a maximum dimension of 0.55 cm (7/32 in.) to 0.6 cm (1/4 in.) from the nominal 0.5 cm (3/16 in.) diameter. These were randomly located on the top, forward, and bottom edges.

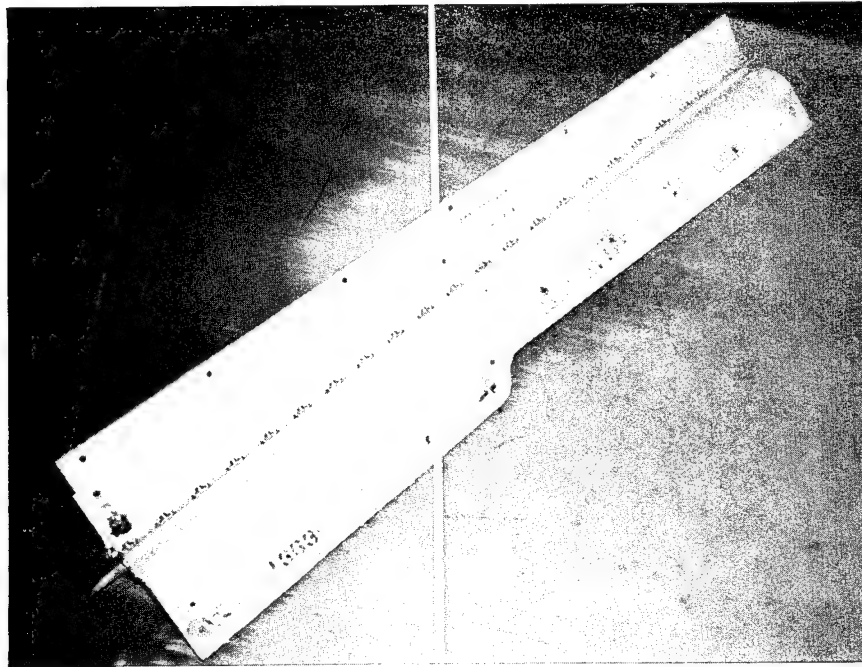
Figure 33. TWA LH Underwing Fillet - Inner Surface

- 1) No damage or defects were observed on either the inner or outer surfaces. (Figure 33). A paint loss area on the upper surface had been repainted since the 1976 inspection.
- 2) Extensive fraying was visible from both the inner and outer surfaces on several fastener holes in the upper fillet sections, which were also slightly elongated. (Figure 34). These included three holes

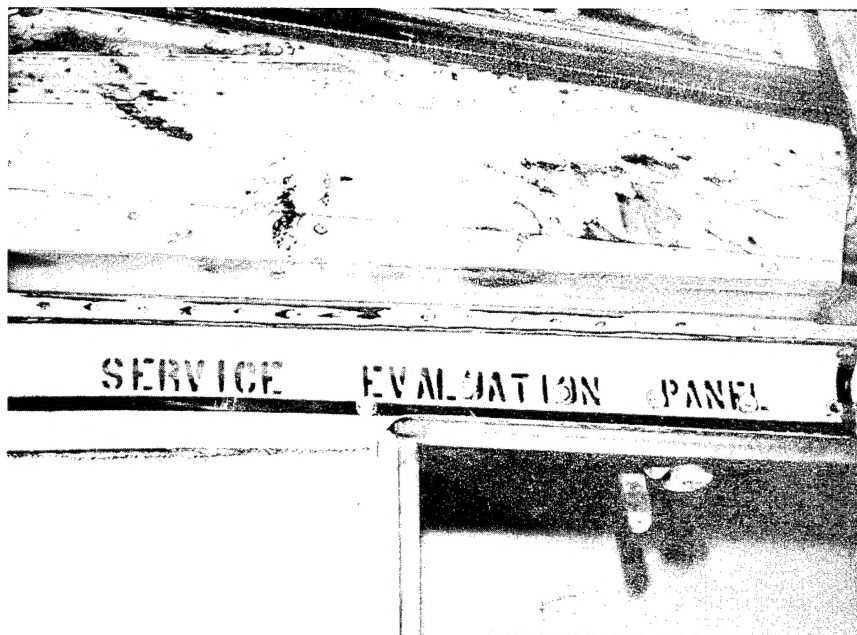
Figure 41. TWA RH Underwing Fillet - Exterior Surface on Aircraft

- 1) No damage or defects were visible on the exterior surface. (Figure 41). The lower aft edge had a bulged appearance indicating possible misalignment. No fasteners showed evidence of misalignment, however.
